Widespread Property Inspections

Property Inspection Report

1234 Awesome Avenue

Inspected on Thu, Aug 22 2024 at 6:40PM

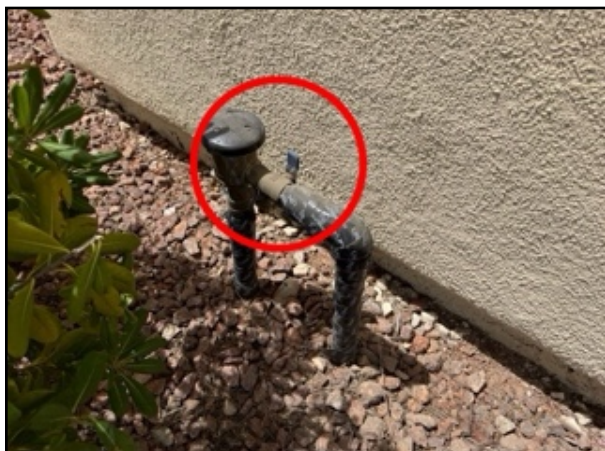
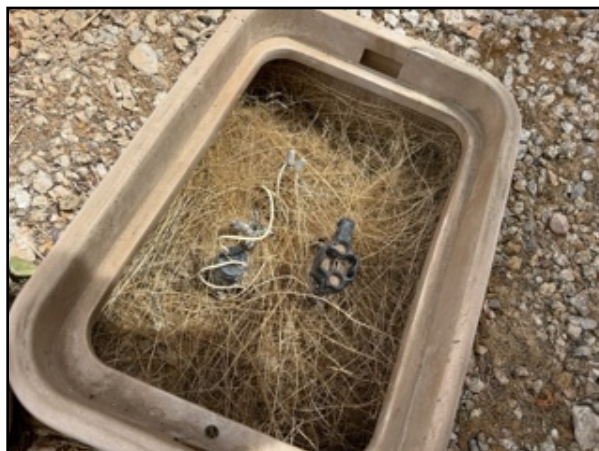
Irrigation anti siphon valve was in the off position at time of inspection. Evidence of previous leaking noted at irrigation valve left side of casita. Further evaluation is recommended.

1) Comment 1: Irrigation anti siphon valve was in the off position at time of inspection. Evidence of previous leaking noted at irrigation valve left side of casita. Further evaluation is recommended.

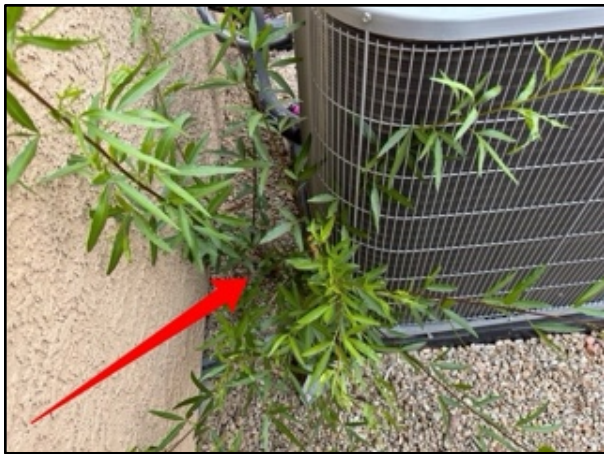
Figure 2-1

Comment 2:
Recommend removing vegetation against air conditioner at right side.

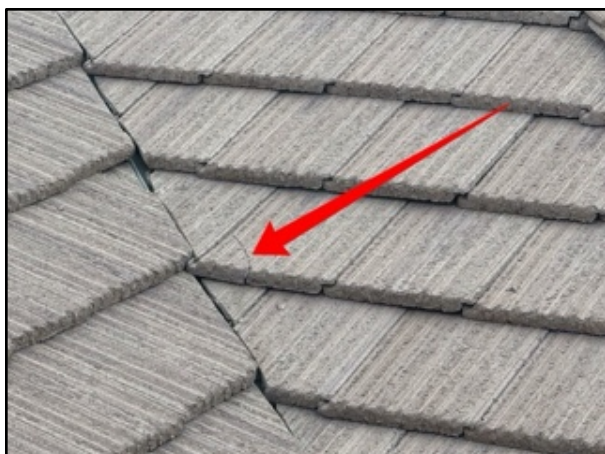
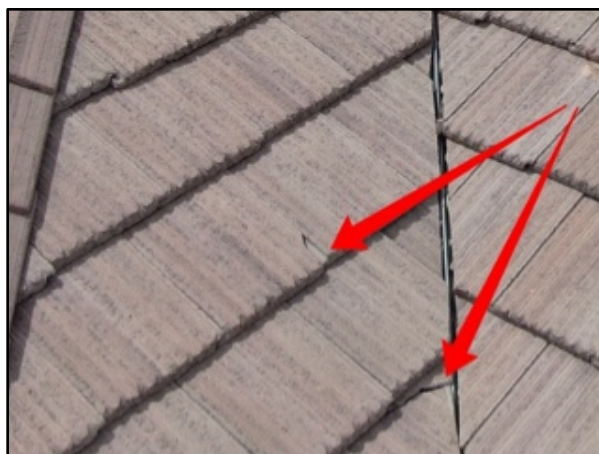
Small crack noted at casita roof tile. A few chipped roof tiles were noted. Evidence of previous repairs was noted. Maintenance is recommended. Recommend further evaluation/repairs by a licensed roofing contractor.

2) Comment 3: Small crack noted at casita roof tile. A few chipped roof tiles were noted. Evidence of previous repairs was noted. Maintenance is recommended. Recommend further evaluation/repairs by a licensed roofing contractor.

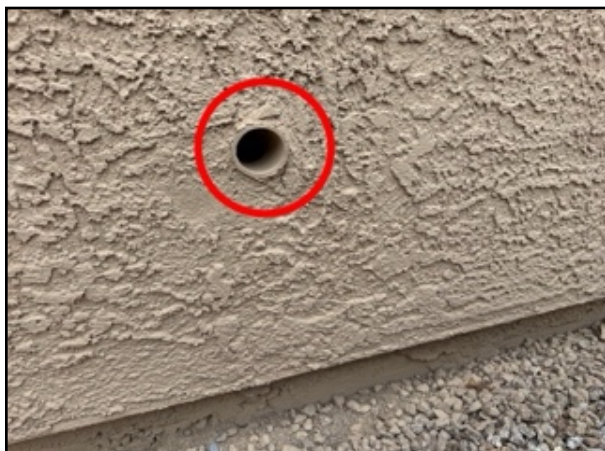
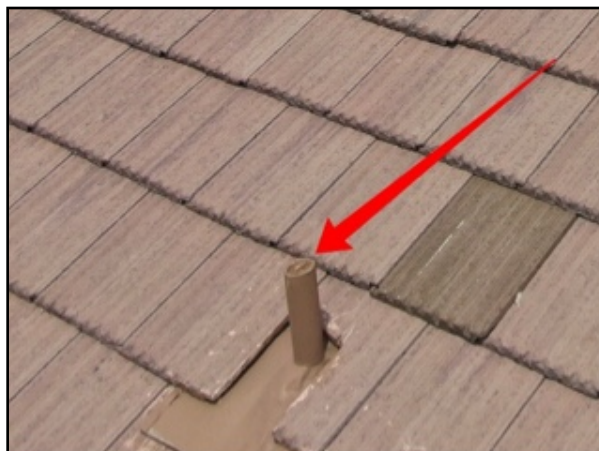
Open waste line clean out noted at right side. Capping is recommended. Plumbing vent appears blocked at left side roof. Recommend further evaluation/repair by a licensed plumber.

3) Comment 4: Open waste line clean out noted at right side. Capping is recommended. Plumbing vent appears blocked at left side roof. Recommend further evaluation/repair by a licensed plumber.

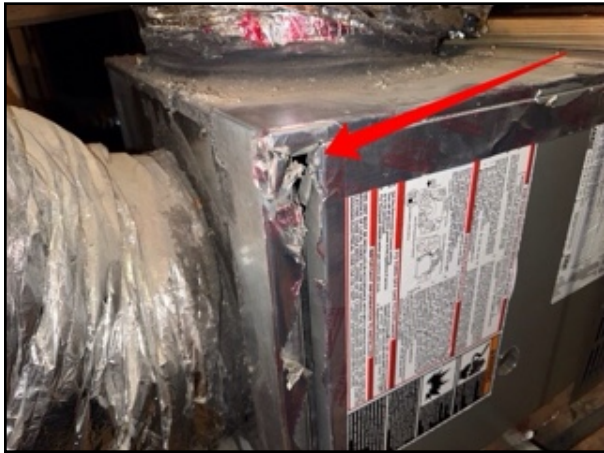
Figure 5-1

**Comment 5:**
Air loss/leakage noted at main air handler. Recommend further evaluation/servicing by a licensed HVAC contractor.

4) Comment 5: Air loss/leakage noted at main air handler. Recommend further evaluation/servicing by a licensed HVAC contractor.

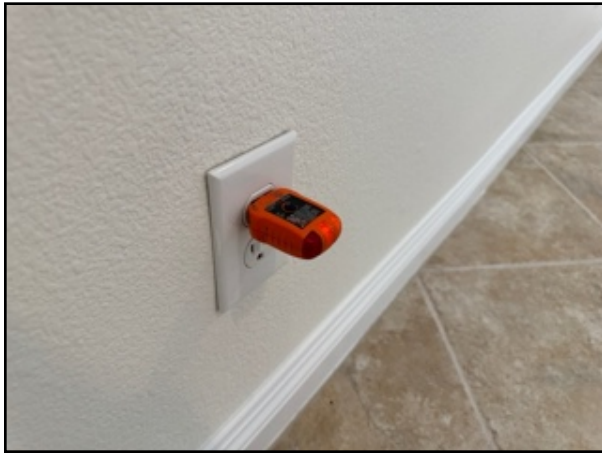
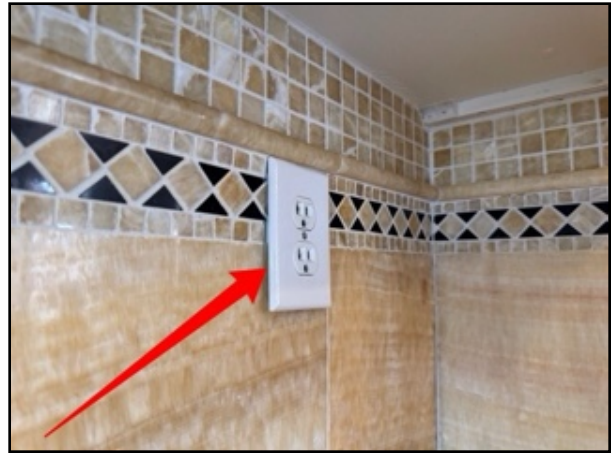
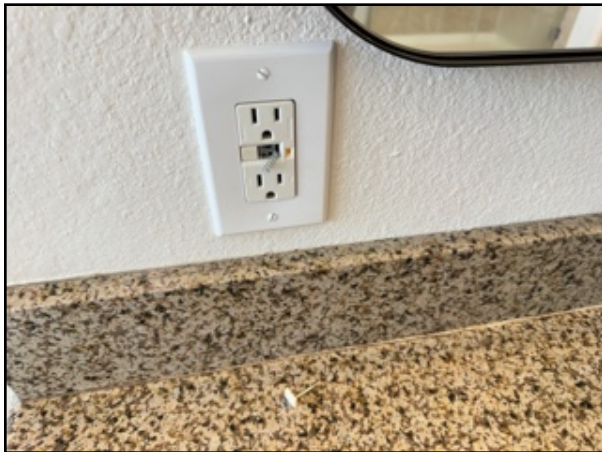
Loose outlets noted at casita and kitchen. GFCI outlet failed during test at primary bathroom. Recommend further evaluation/repair by a licensed electrician.

5) Comment 6: Loose outlets noted at casita and kitchen. GFCI outlet failed during test at primary bathroom. Recommend further evaluation/repair by a licensed electrician.

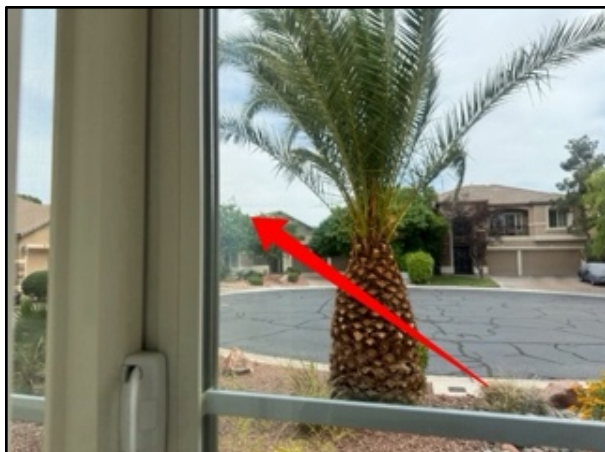
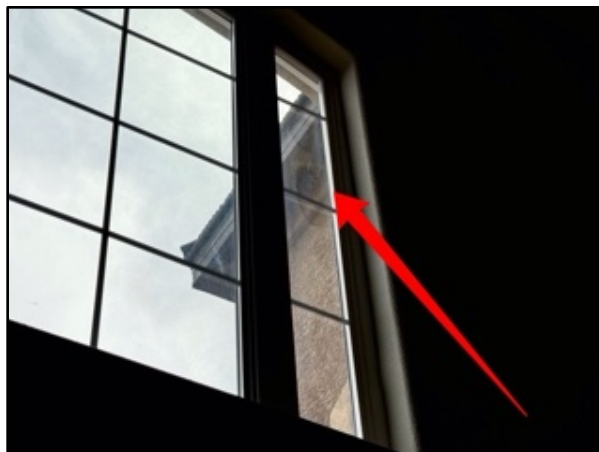
Evidence of dual pane window seal failure noted at great room windows. Further evaluation is recommended.

6) Comment 7: Evidence of dual pane window seal failure noted at great room windows. Further evaluation is recommended.

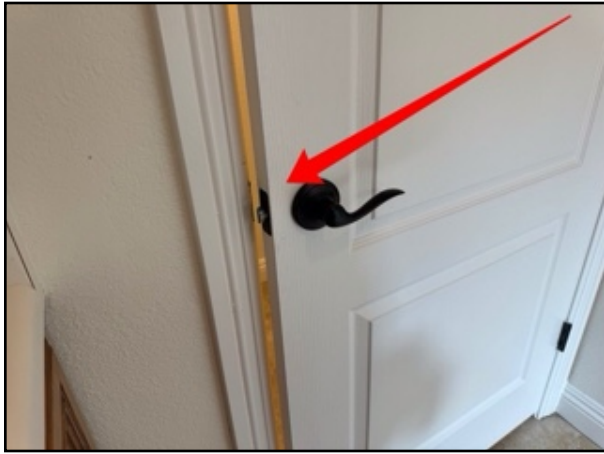
Figure 8-1

Comment 8:
Door did not latch properly at laundry room.

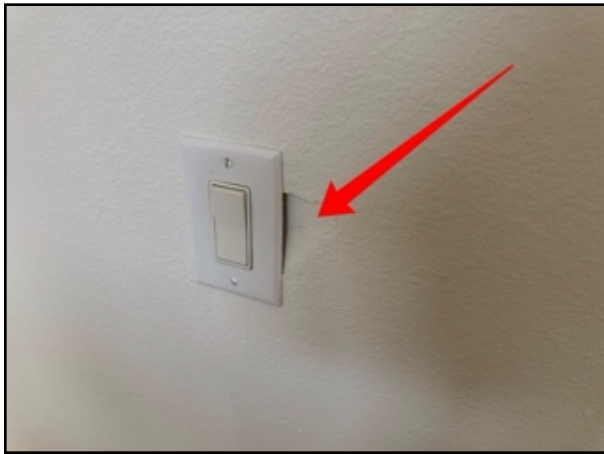
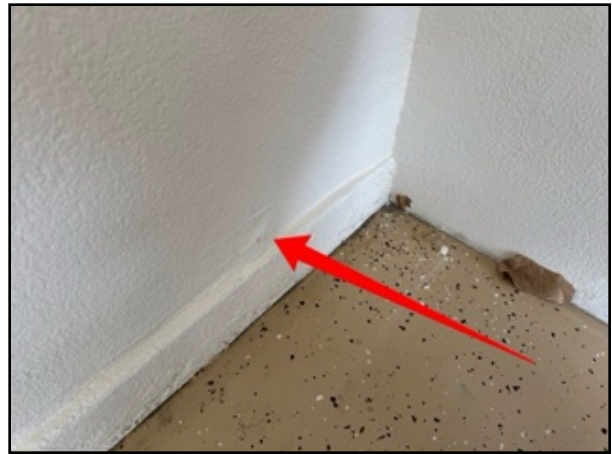
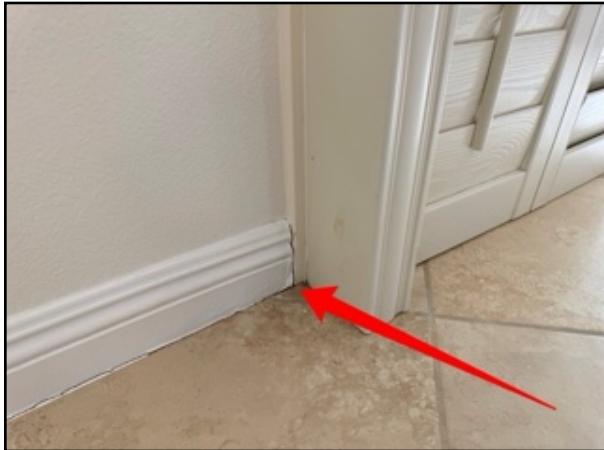
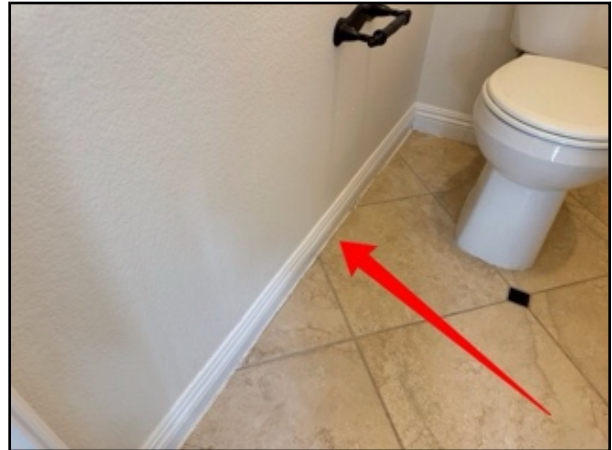
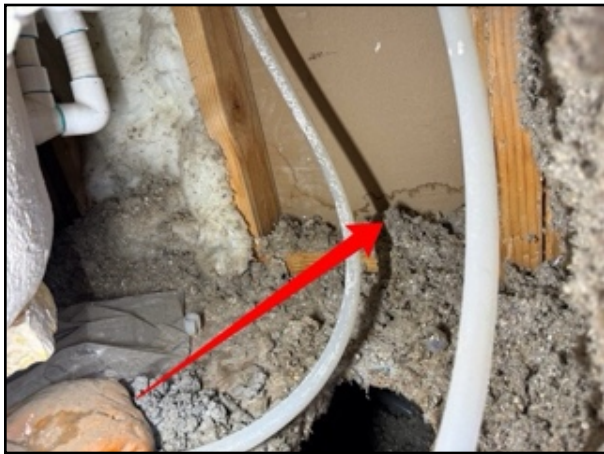
Comment 9:
Drywall blemish noted at casita adjacent to light switch. Evidence of previous moisture exposure noted at garage, primary bedroom and primary bathroom under tub. Area was dry at time of inspection.

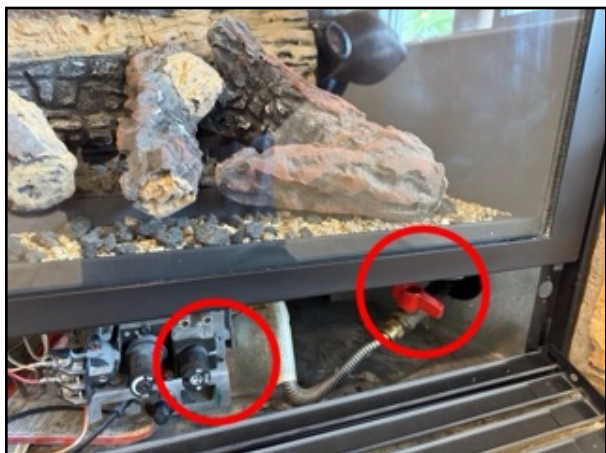
Figure 10-1

Unable to get pilot to remain lit at family room fireplace. Gas valve was off upon initial inspection. Further evaluation/repair is recommended.

7) Comment 10: Unable to get pilot to remain lit at family room fireplace. Gas valve was off upon initial inspection. Further evaluation/repair is recommended.

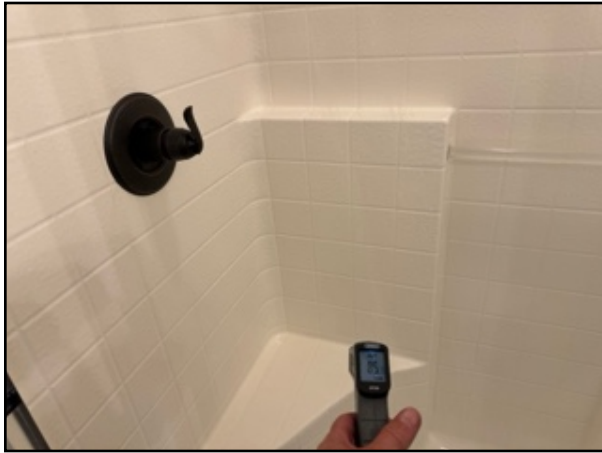
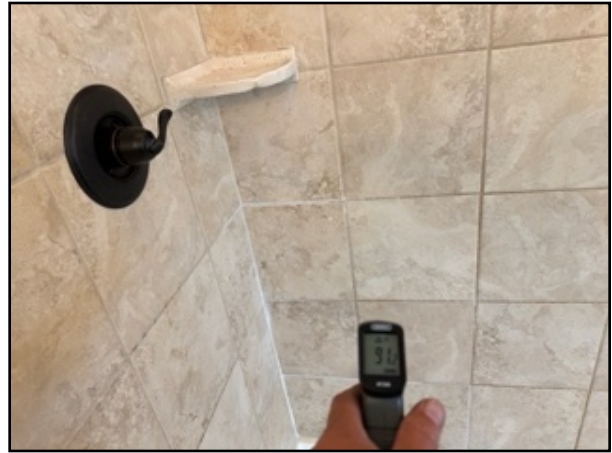
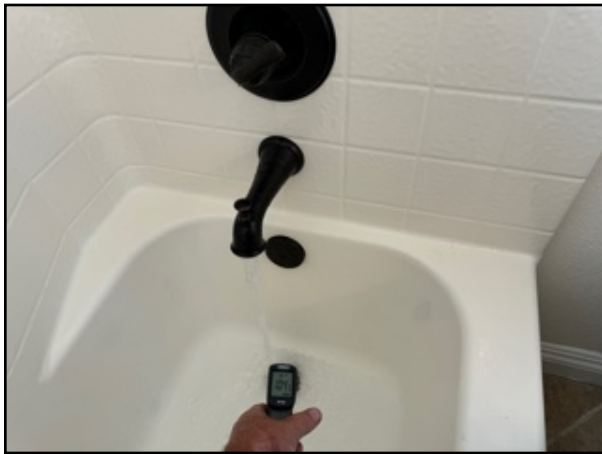
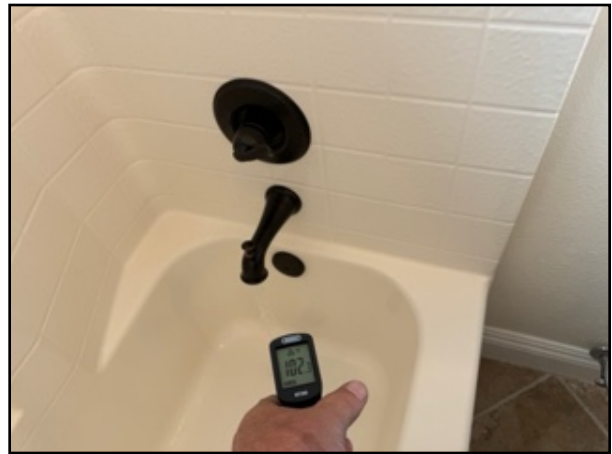
Hot/cold reversed noted at casita, primary bathroom, jack/jill bathroom and fourth bathroom shower/tub faucets. Recommend further evaluation/repair by a licensed plumber.

8) Comment 11: Hot/cold reversed noted at casita, primary bathroom, jack/jill bathroom and fourth bathroom shower/tub faucets. Recommend further evaluation/repair by a licensed plumber.

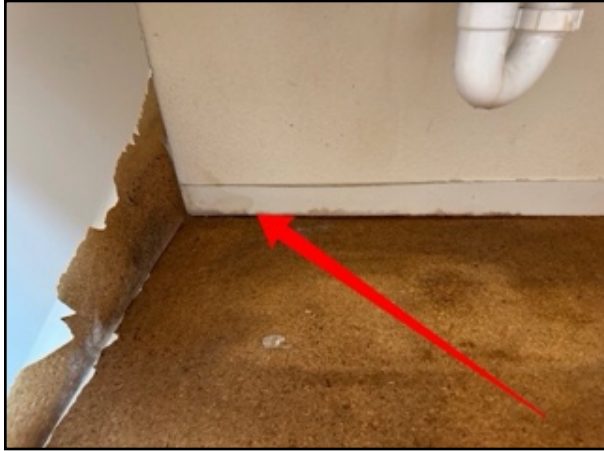
Figure 12-1

Evidence of previous moisture exposure and possible fungal growth noted under lower hall bathroom sink. Further evaluation/repair is recommended.

9) Comment 12: Evidence of previous moisture exposure and possible fungal growth noted under lower hall bathroom sink. Further evaluation/repair is recommended.

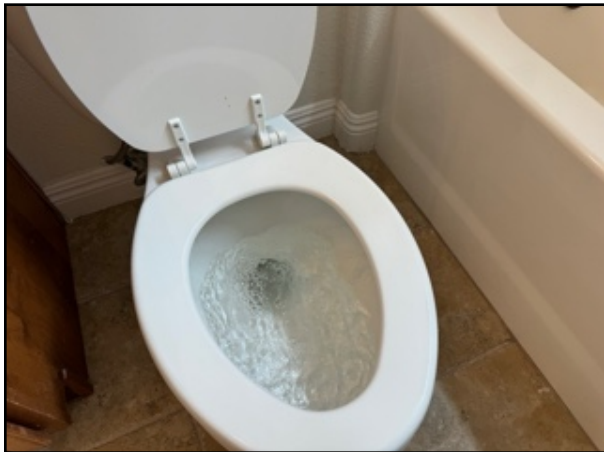
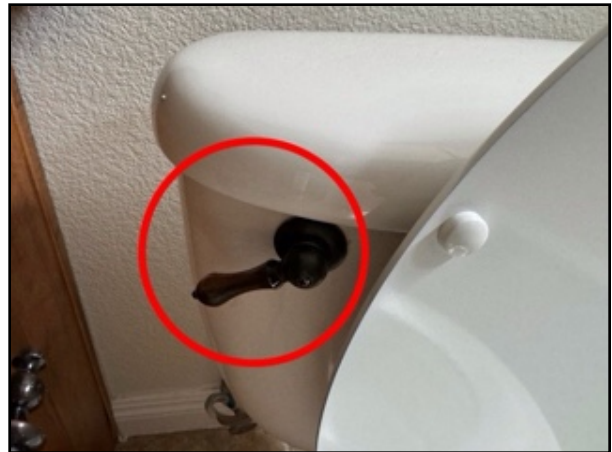
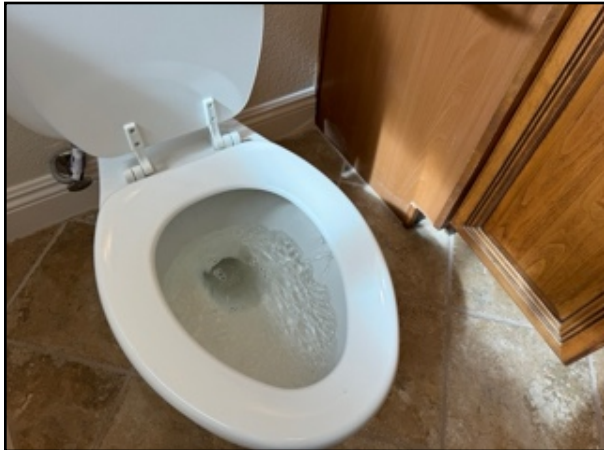
Toilet was slow to flush and handle sticks at lower hall bathroom. Toilet did not flush properly at fourth bathroom. Recommend further evaluation/repair by a licensed plumber.

10) Comment 13: Toilet was slow to flush and handle sticks at lower hall bathroom. Toilet did not flush properly at fourth bathroom. Recommend further evaluation/repair by a licensed plumber.

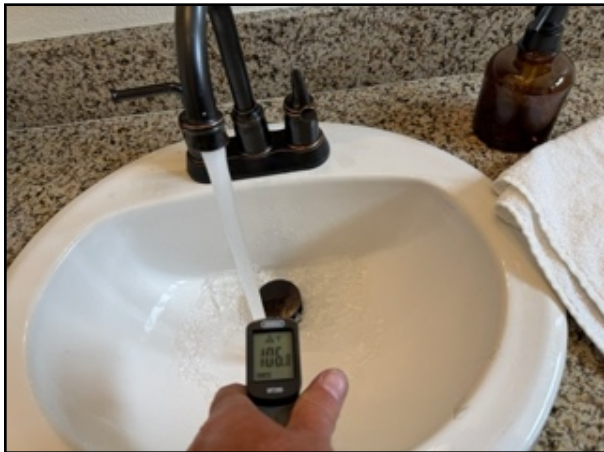
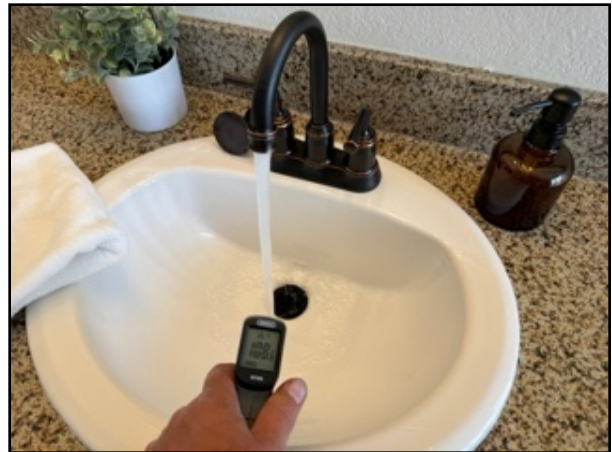
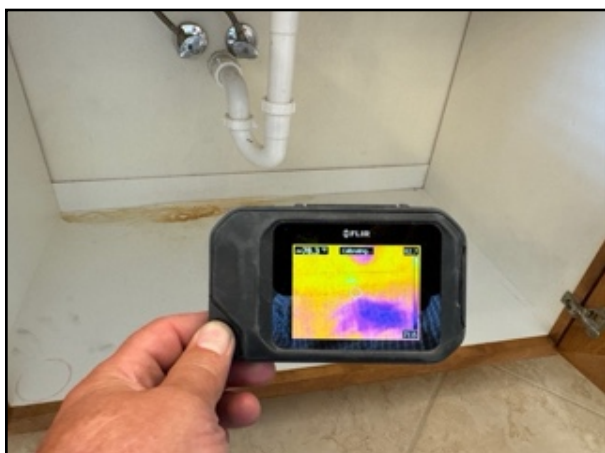
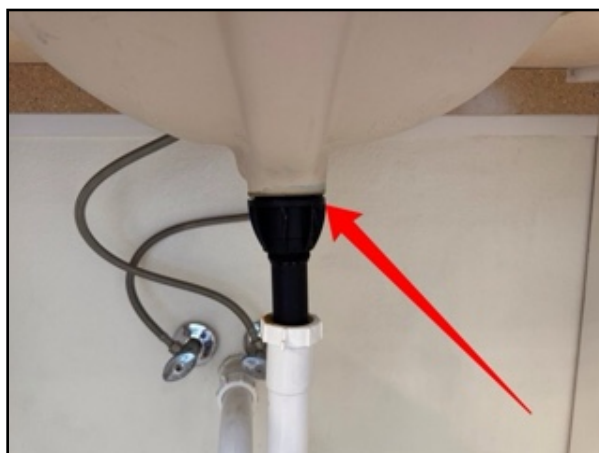
Hot/cold was reversed at lower hall bathroom sink and left primary bathroom sink. Drain was leaking at right primary bathroom sink. Recommend further evaluation/repair by a licensed plumber.

11) Comment 14: Hot/cold was reversed at lower hall bathroom sink and left primary bathroom sink. Drain was leaking at right primary bathroom sink. Recommend further evaluation/repair by a licensed plumber.

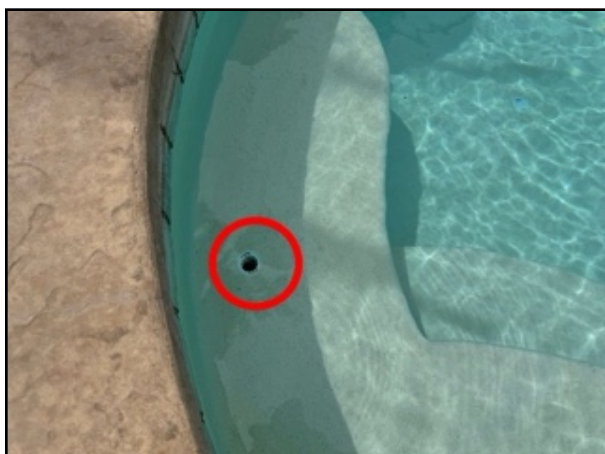
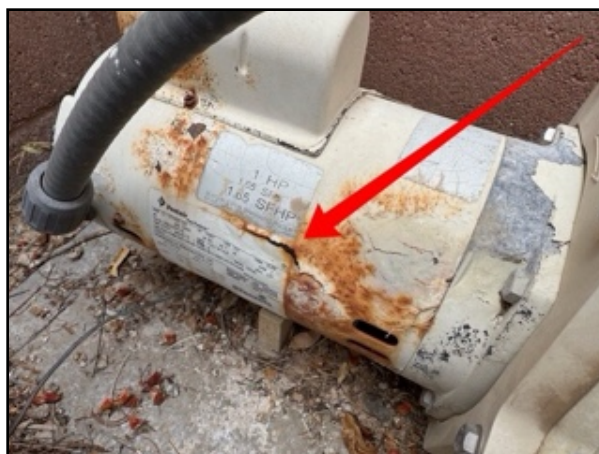
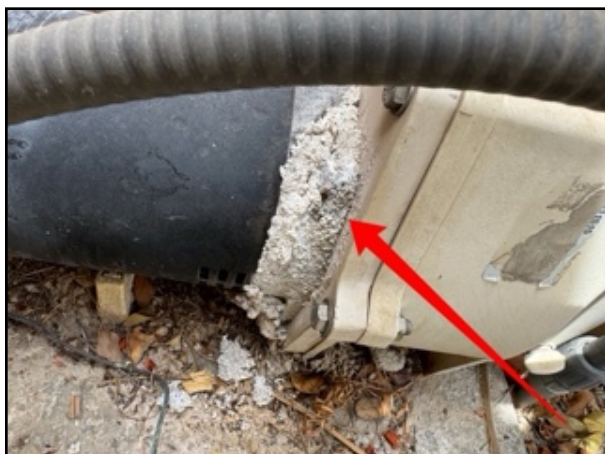
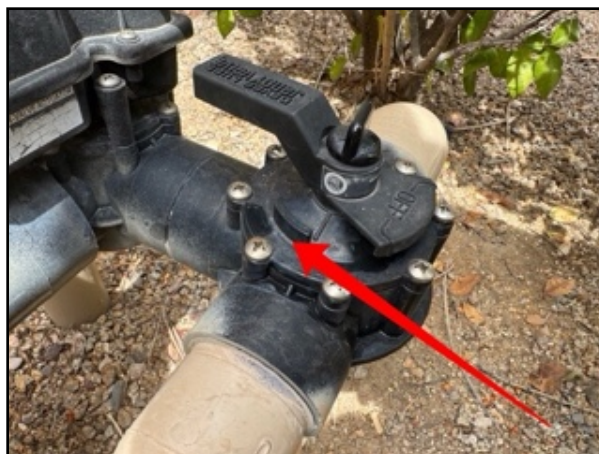
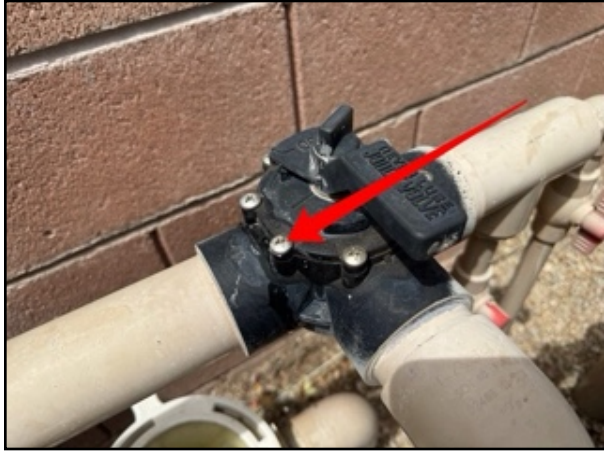
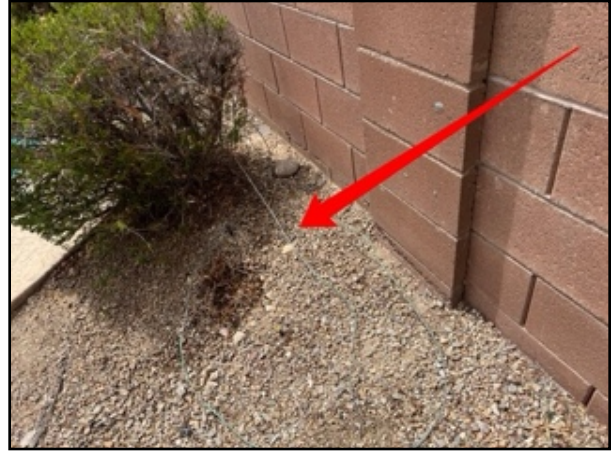
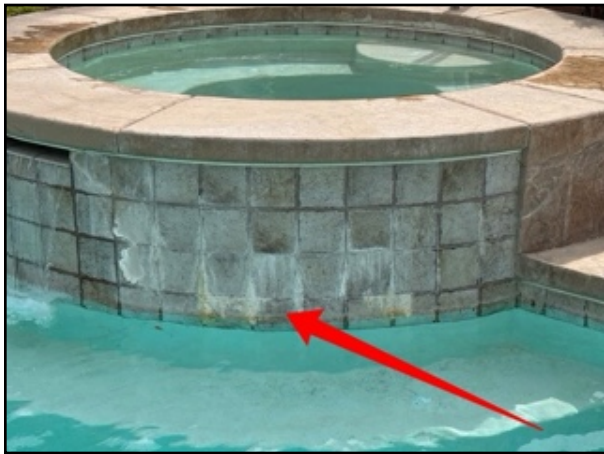
Comment 15:
Pool in floor cleaner pop up was missing. Deterioration noted at water feature pump. Corrosion noted at primary pump. Leaking noted at valves. Loose bond wire noted right of pool. Significant calcium noted at spa tiles. Recommend further evaluation of entire system by a licensed pool contractor.

12) Comment 15: Pool in floor cleaner pop up was missing. Deterioration noted at water feature pump. Corrosion noted at primary pump. Leaking noted at valves. Loose bond wire noted right of pool. Significant calcium noted at spa tiles. Recommend further evaluation of entire system by a licensed pool contractor.
